**Flood Control Project Maintenance
Levee Inspections**

2016 Channel Summary Report

Placer County

Truckee River

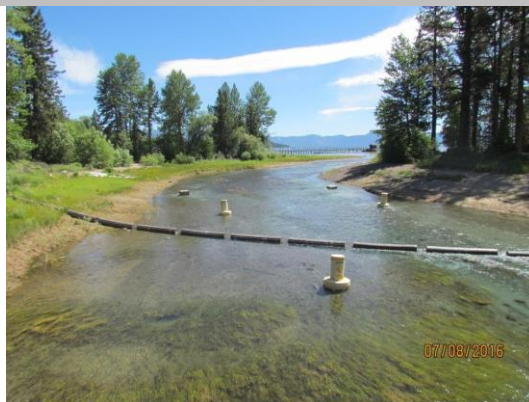
Photo 1 of 2 : CH_2016_NA0045_13_1_20160721_00021.jpg

Rating **	A	Issue No.	1	GPS Lat/Long
Issue Type +	Ma	Location *		39.167101 °
Category	Rivers, Channels & Designated Flood			-120.144002 °
Item	Vegetation & Obstructions			
DWR ID	DWR_NA0045_13_c_2012_1			
Action/Comments				
Inspector Comments: Minimal, scattered obstructions or vegetation. The flow is not impeded.

View of the Truckee River looking upstream from the outlet structure towards Lake Tahoe. Summer 2016.

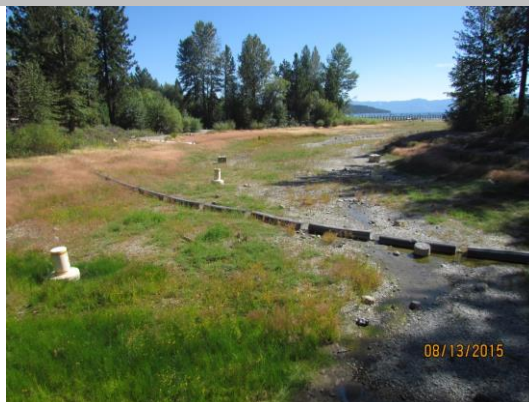
Photo 2 of 2 : CH_2016_NA0045_13_1_20160620_00001.jpg

Looking upstream from the outlet structure. Summer 2015.

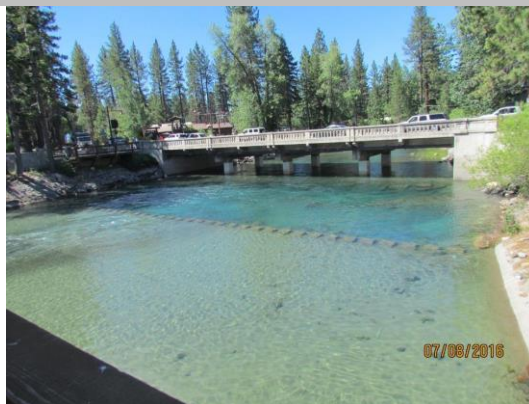
Photo 1 of 2 : CH_2016_NA0045_13_6_20160721_00022.jpg

Rating **	A	Issue No.	6	GPS Lat/Long
Issue Type +	Ma	Location *		39.167101 °
Category	Rivers, Channels & Designated Flood			-120.144002 °
Item	Vegetation & Obstructions			
DWR ID	DWR_NA0045_13_c_2012_6			
Action/Comments				
Inspector Comments: Minimal, scattered obstructions or vegetation. The flow is not impeded.

View of the river looking downstream from the outlet structure towards Highway 89. Summer 2016.

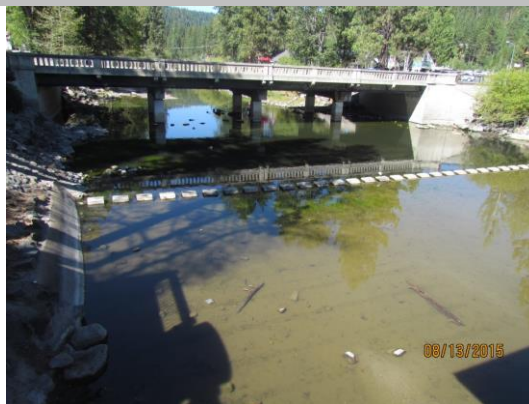
Photo 2 of 2 : CH_2016_NA0045_13_6_20160620_00004.jpg

Looking downstream from the outlet structure. Summer 2015.

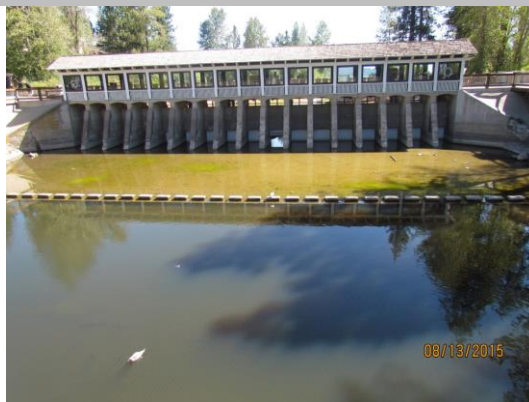
Photo 2 of 2 : CH_2016_NA0045_13_11_20160620_00007.jpg

Looking upstream from Highway 89. Summer 2015.

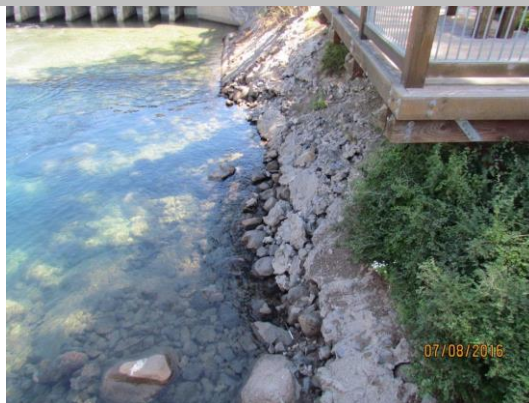
Photo 1 of 1 : CH_2016_NA0045_13_14_20160721_00024.jpg

Rating **	A	Issue No.	14	GPS Lat/Long
Issue Type +	Ma	Location *		39.166845 °
Category	Rivers, Channels & Designated Flood			-120.144424 °
Item	Revetments			
DWR ID	DWR_NA0045_13_c_2012_14			
Action/Comments				
Inspector Comments: Existing riprap protection is properly maintained and is undamaged. Riprap clearly visible. Monitor scouring revetment on the slope of the left bank.

Revetments are starting to show signs of scouring. Monitor revetments. Summer 2016.

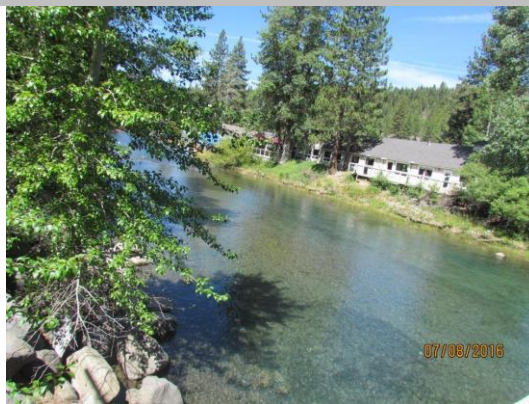
Photo 1 of 2 : CH_2016_NA0045_13_16_20160721_00025.jpg

Rating **	A	Issue No.	16	GPS Lat/Long
Issue Type +	Ma	Location *		39.166845 °
Category	Rivers, Channels & Designated Flood			-120.144424 °
Item	Vegetation & Obstructions			
DWR ID	DWR_NA0045_13_c_2012_16			
Action/Comments				
Inspector Comments: Minimal, scattered obstructions or vegetation. The flow is not impeded.

View of the river looking downstream from Highway. Summer 2016.

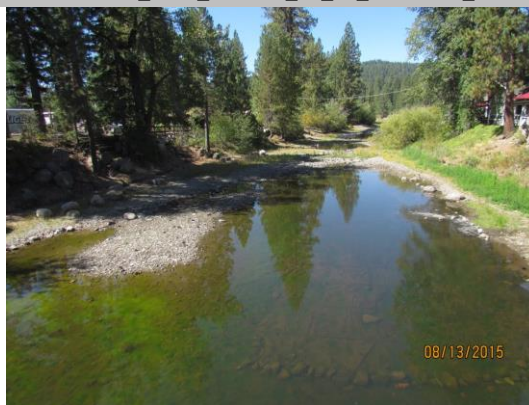
Photo 2 of 2 : CH_2016_NA0045_13_16_20160620_00009.jpg

Looking downstream from Highway 89. Summer 2015.

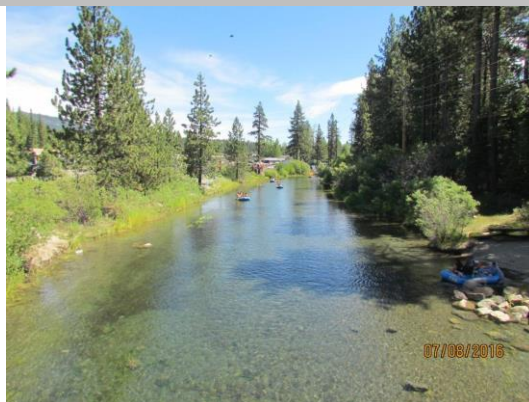
Photo 1 of 2 : CH_2016_NA0045_13_21_20160721_00026.jpg

Inspector Comments: Minimal, scattered obstructions or vegetation. The flow is not impeded.

View of the river looking upstream from the bike bridge. Summer 2016.

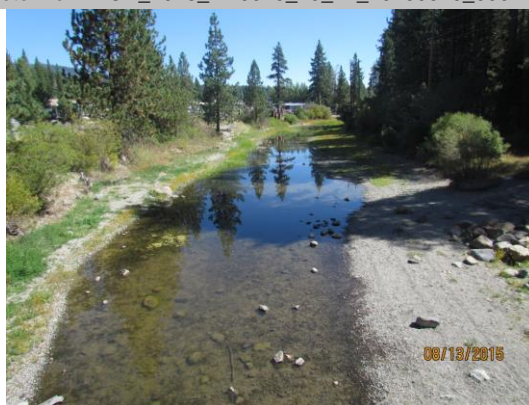
Photo 2 of 2 : CH_2016_NA0045_13_21_20160620_00011.jpg

Looking upstream from the bike bridge. Summer 2015.

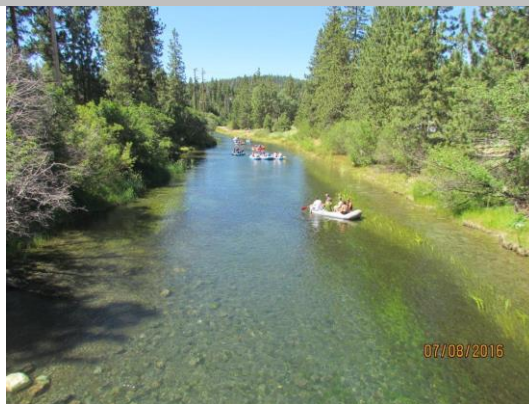
Photo 1 of 2 : CH_2016_NA0045_13_26_20160721_00027.jpg

Rating **	A	Issue No.	26	GPS Lat/Long
Issue Type +	Ma	Location *		39.165170 °
Category	Rivers, Channels & Designated Flood			-120.147590 °
Item	Vegetation & Obstructions			
DWR ID	DWR_NA0045_13_c_2012_26			
Action/Comments				
Inspector Comments: Minimal, scattered obstructions or vegetation. The flow is not impeded.

View of the river looking down from the bike bridge. Summer 2016.

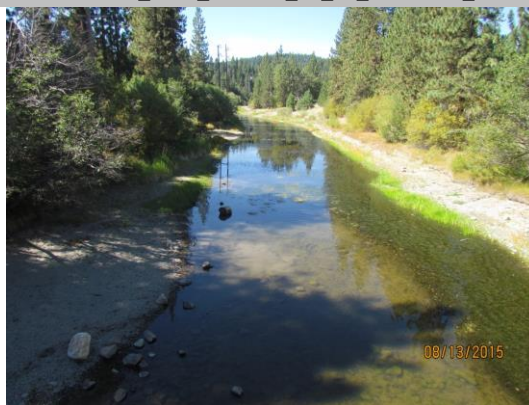
Photo 2 of 2 : CH_2016_NA0045_13_26_20160620_00013.jpg

Looking downstream from the bike bridge. Summer 2015.

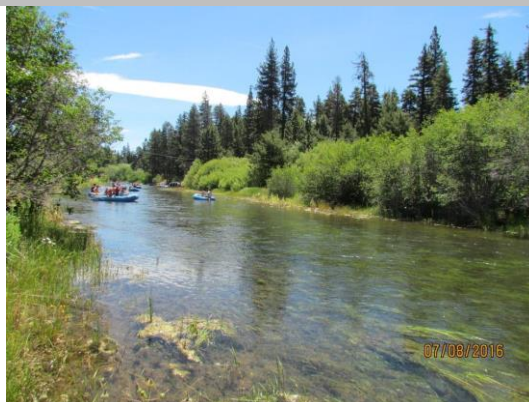
Photo 2 of 2 : CH_2016_NA0045_13_31_20160721_00029.jpg

View of the river looking upstream from Tahoe City Lumber Yard (39.162564, -120.153385). Summer 2016.

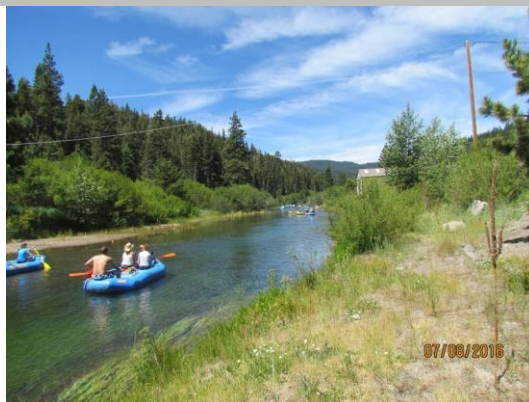
Photo 1 of 2 : CH_2016_NA0045_13_36_20160721_00030.jpg

Inspector Comments: Minimal, scattered obstructions or vegetation. The flow is not impeded.

View of the river looking downstream from Tahoe City Lumber Yard (36.162499, -120.151878). Summer 2016.

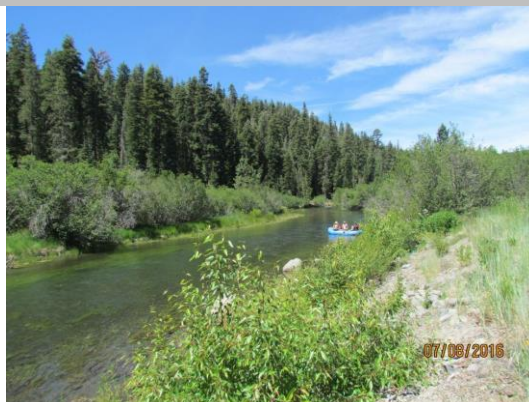
Photo 2 of 2 : CH_2016_NA0045_13_36_20160721_00031.jpg

View of the river looking downstream from Tahoe City Lumber Yard (39.162564, -120.153385). Summer 2016.
